# Assessment of Dam Safety

## Coal Combustion Surface Impoundments (Task 3)

American Electric Power

Big Sandy  
Generating Station

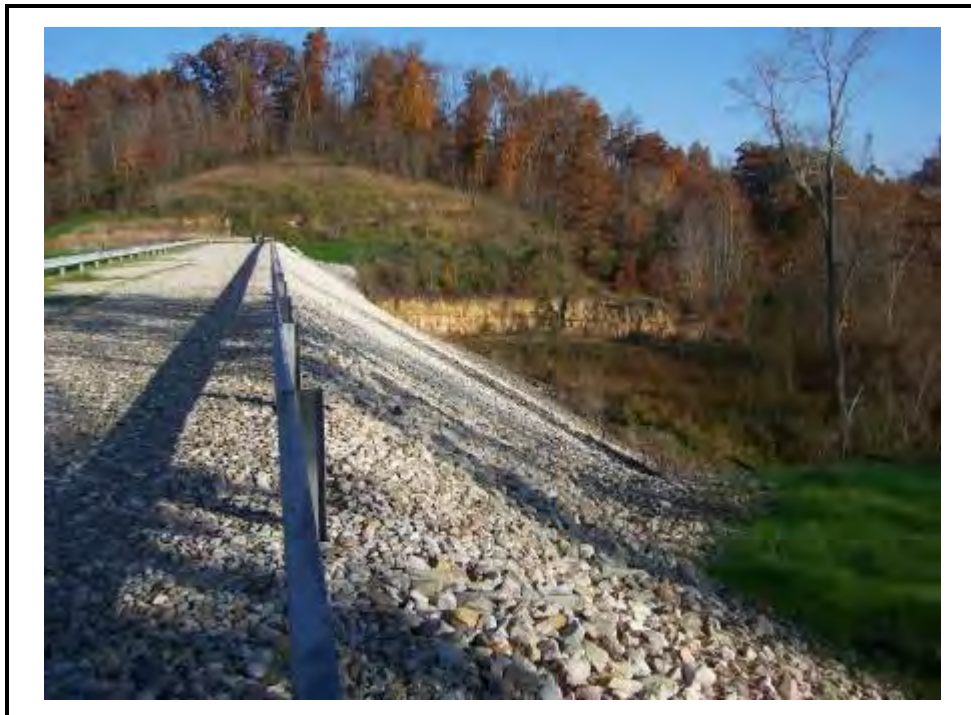
The upstream and downstream slopes were reasonably uniformly graded. The grass cover on the upstream slope appeared well maintained as shown in Photo 1. As shown in Photo 9, there is some grading irregularity on the south end of the upstream slope where the upstream slope meets the crest. The stone covered downstream slope appeared generally clear of vegetation as shown in Photo 2. However, brush and small trees were observed within the stone at the south and north groins (Photos 2 through 6). Plant personnel indicated that the small trees have been sprayed with herbicide.

Downstream slope of Saddle Dam, looking north.

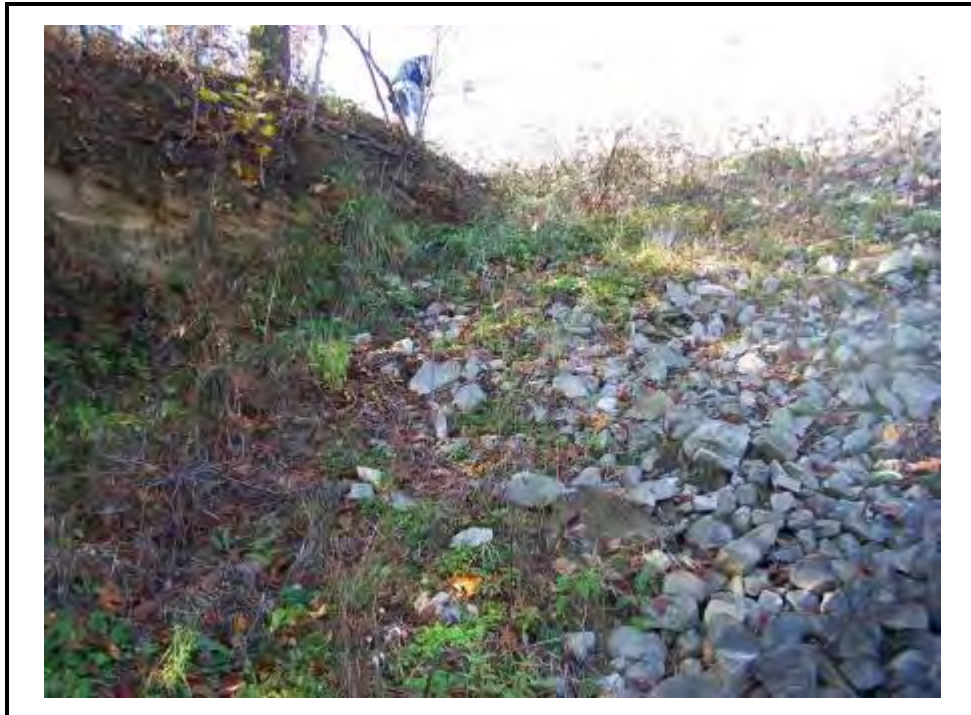
3

South groin of downstream slope and abutment at Saddle Dam.

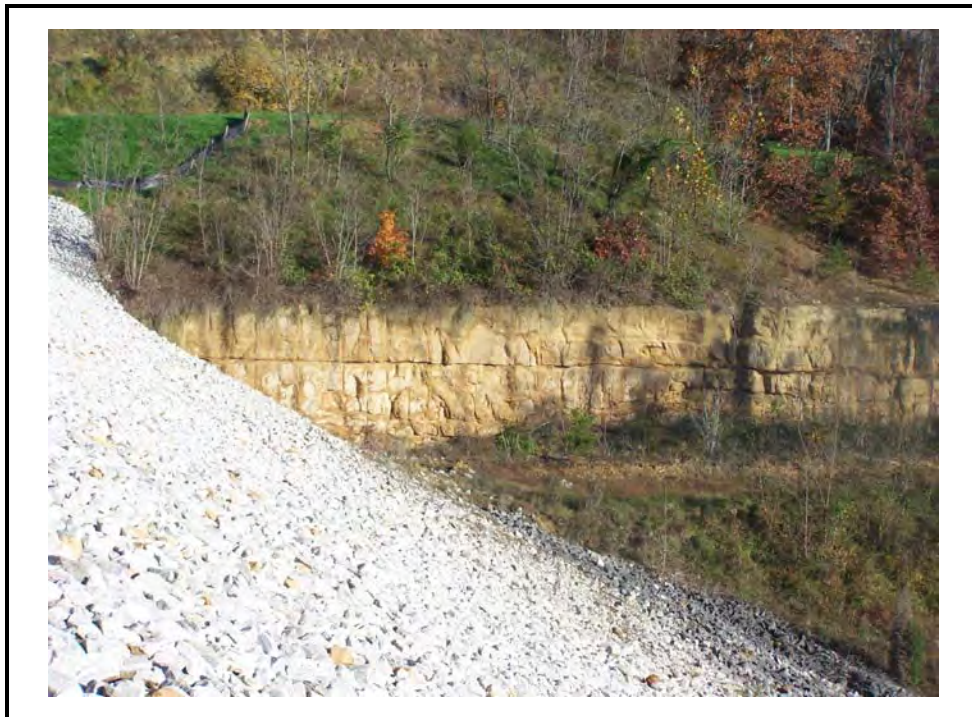
6

Downstream slope in original emergency spillway, looking north.

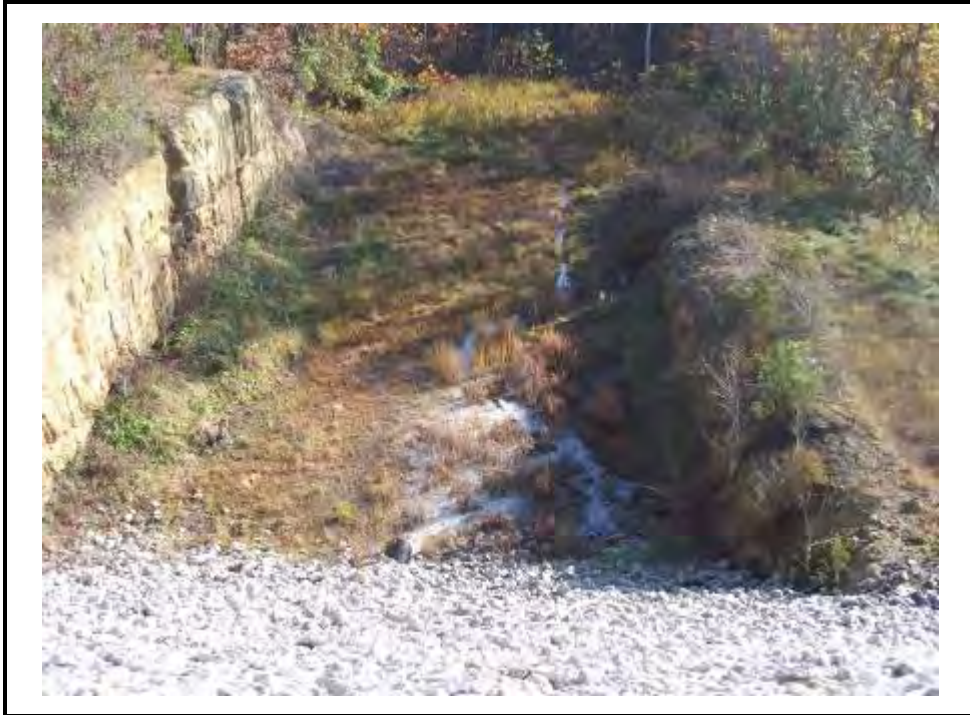
The Saddle Dam was constructed across the original emergency spillway, as shown in Photos 12 and 13, as part of the Phase 3 construction. A seepage drain is located within the old spillway as shown in Photos 7 and 14; plant personnel indicated that this drain has a constant flow. Apparent calcium deposits have formed at the seepage drain within the old emergency spillway as shown in Photo 14. Plant personnel indicated that the filter blanket materials for this seepage drain were derived from crushed limestone which is readily available in the area. A “new” emergency spillway was constructed at the north abutment of the Saddle Dam as shown in Photos 15 and 16. The Emergency Spillway outlet and inlet are shown in Photos 17 and 18, respectively.

Original emergency spillway.  
Seepage drain at approximate midpoint of channel.

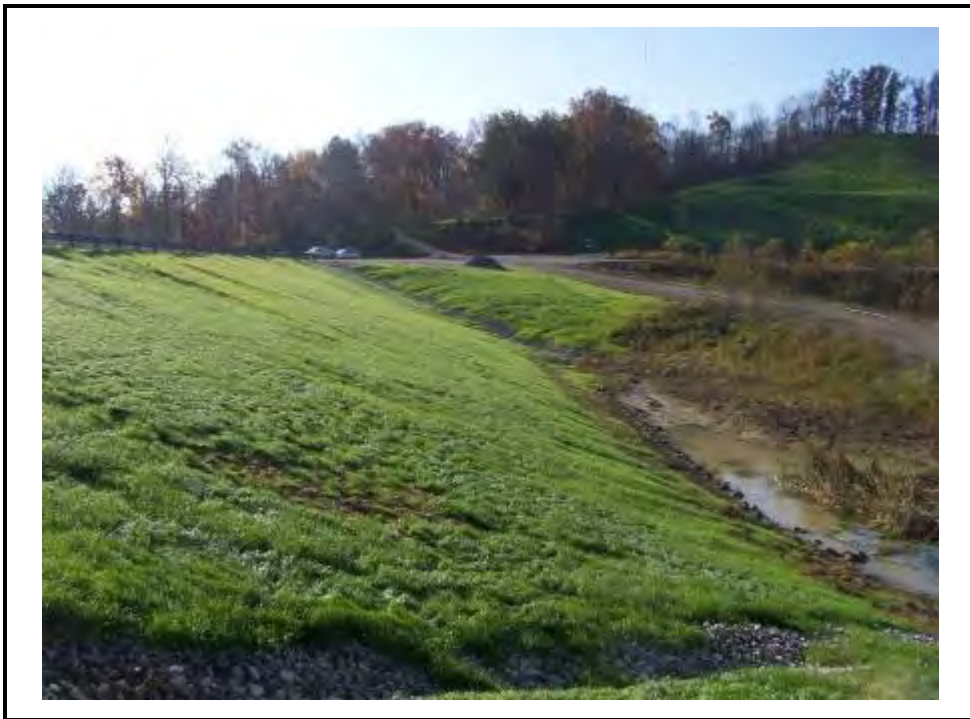
8

Upstream slope of Saddle Dam, looking south.

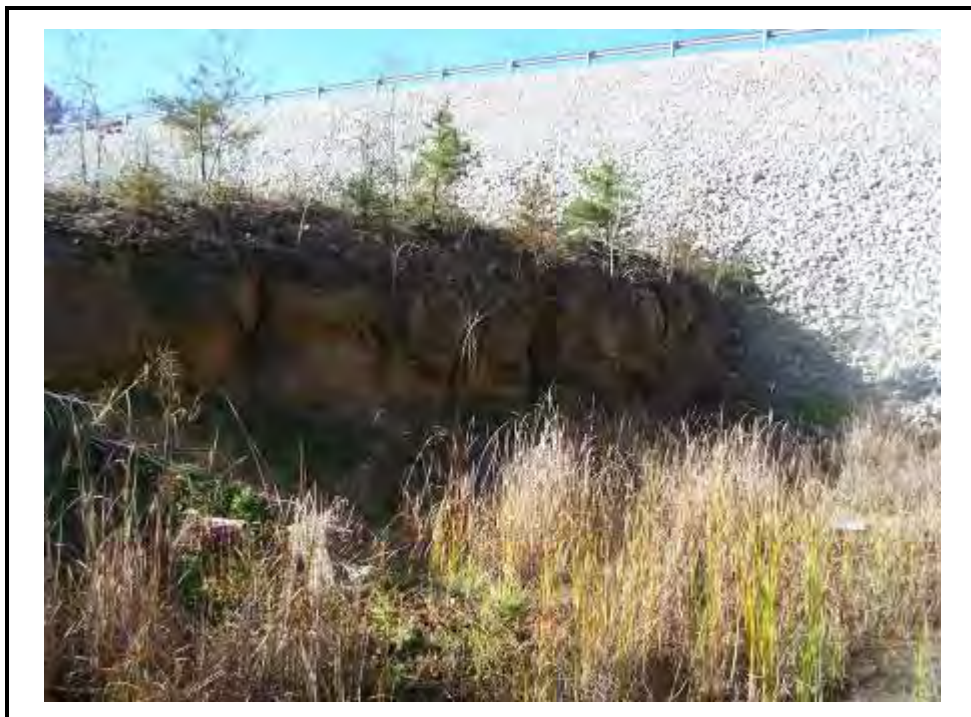
12

Downstream slope of Saddle Dam filling original emergency spillway.

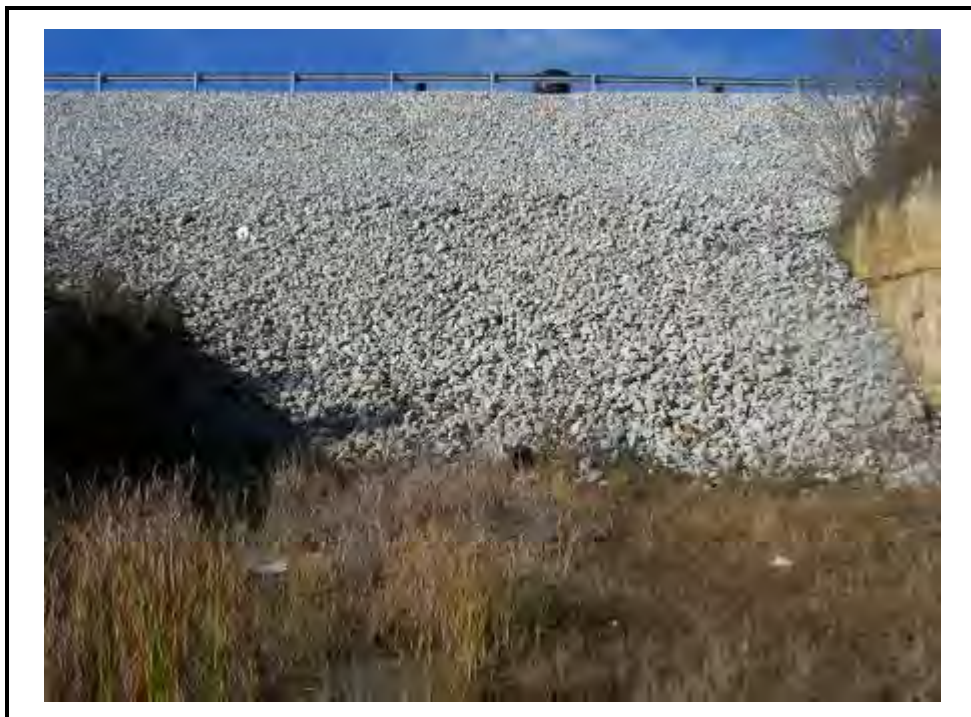
13

Downstream slope of Saddle Dam filling original emergency spillway.

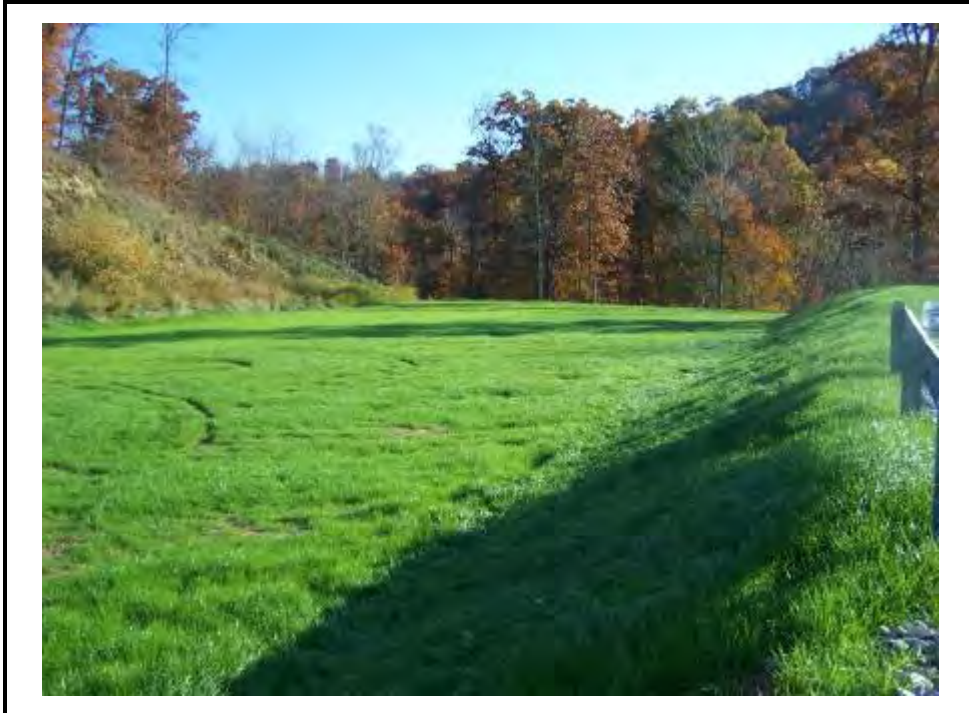
15

“New” emergency spill way at north abutment of Saddle Dam.

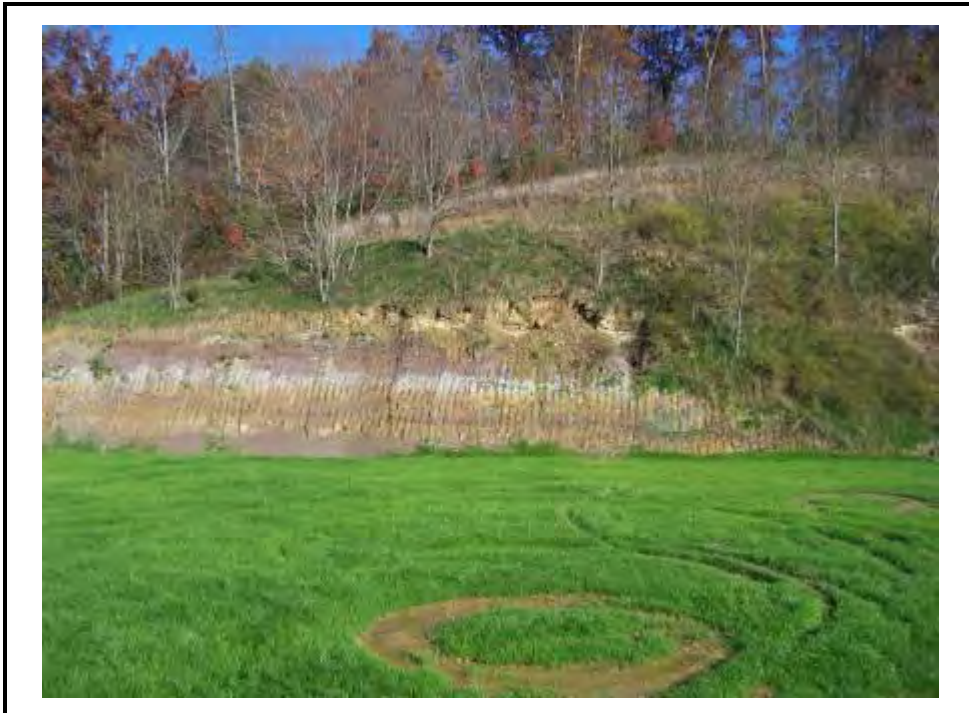
16

North abutment contact of “new” emergency spillway.

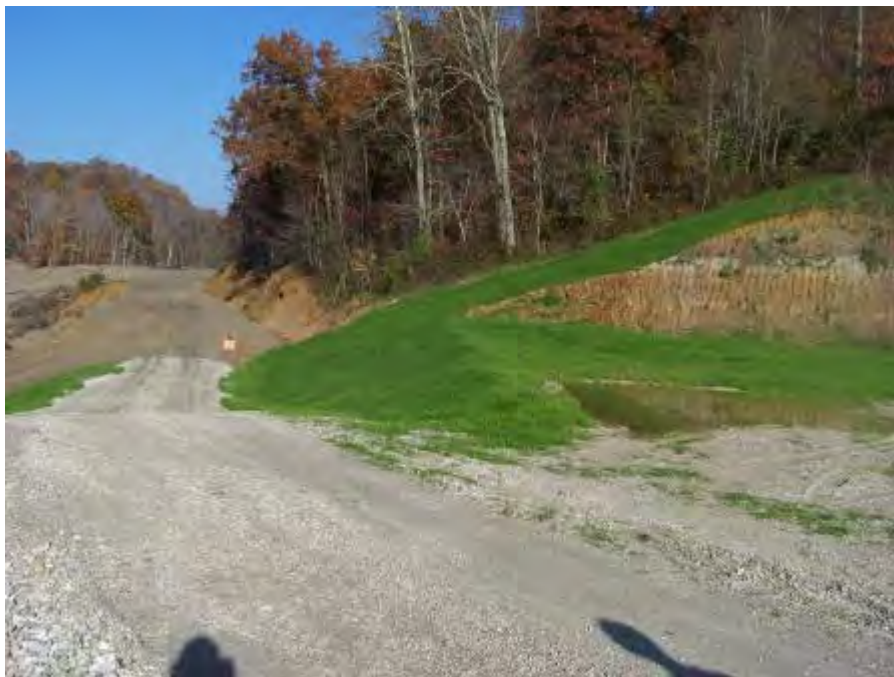
18

Entrance of “new” emergency spillway.

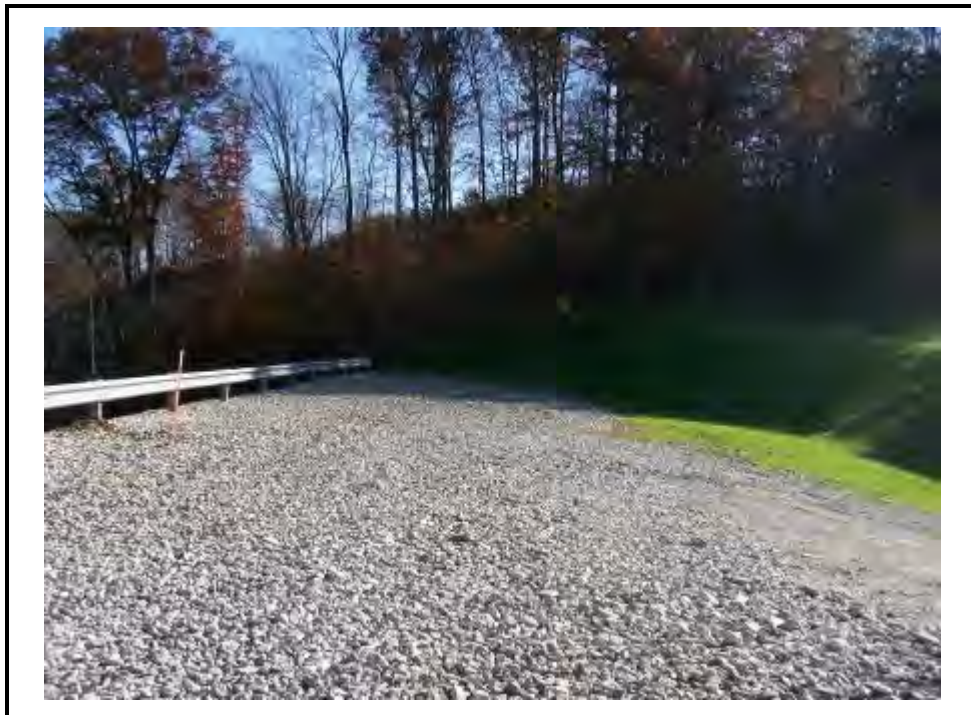
19

East abutment and crest of Horseford Creek Dam, looking east.

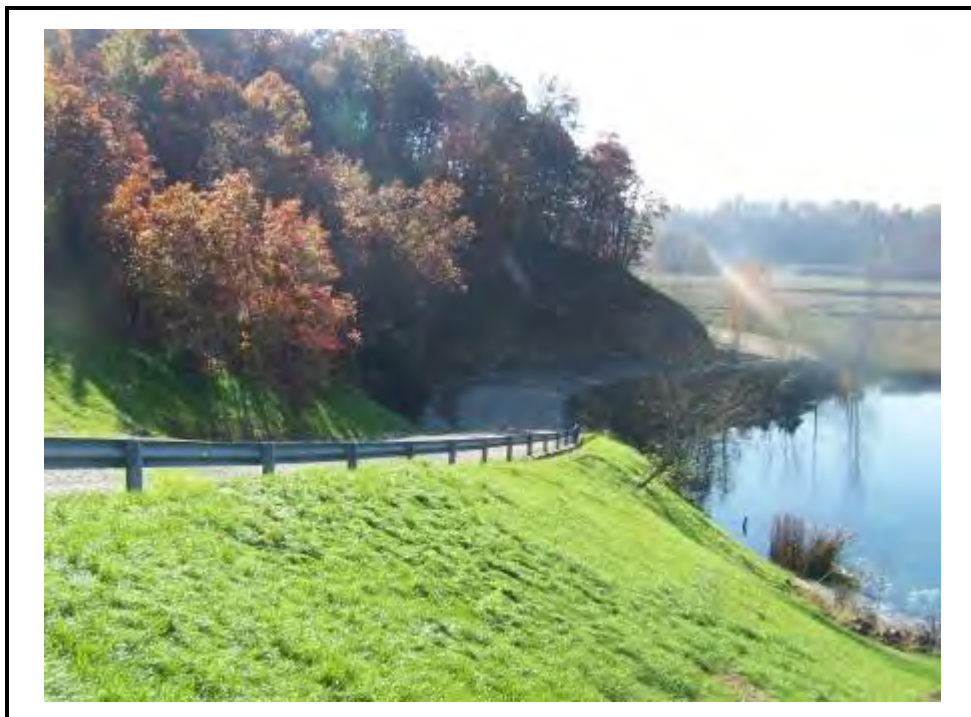
20

Access road up east abutment/Horseford Creek Dam contact, looking east.

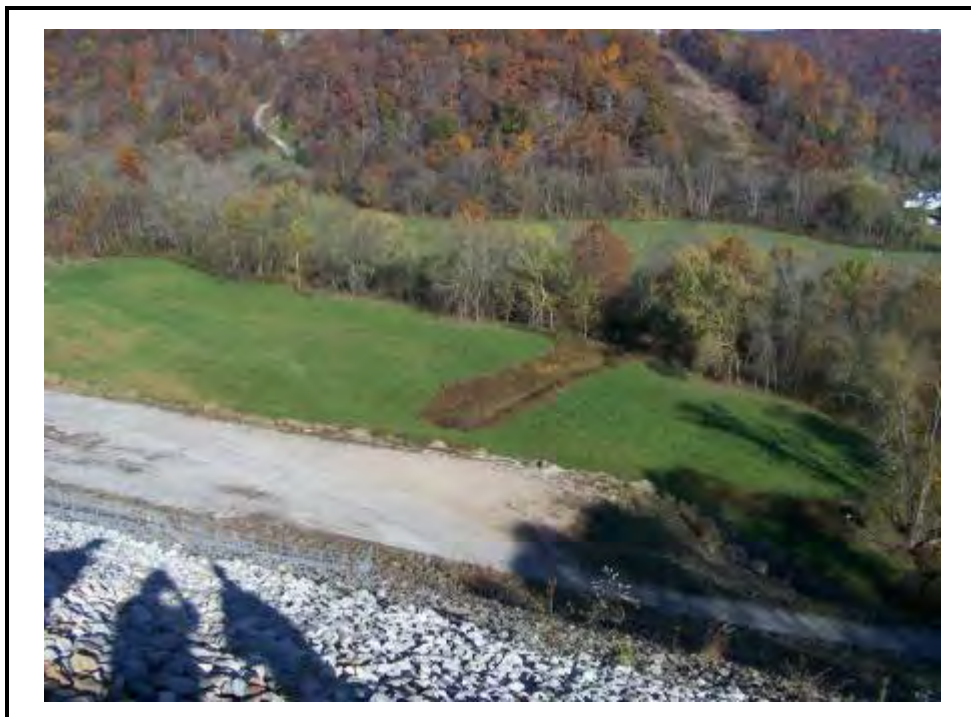
22

Downstream slope and buttress of Horseford Creek Dam looking north.  
Channel in field is original discharge channel which is now abandoned.

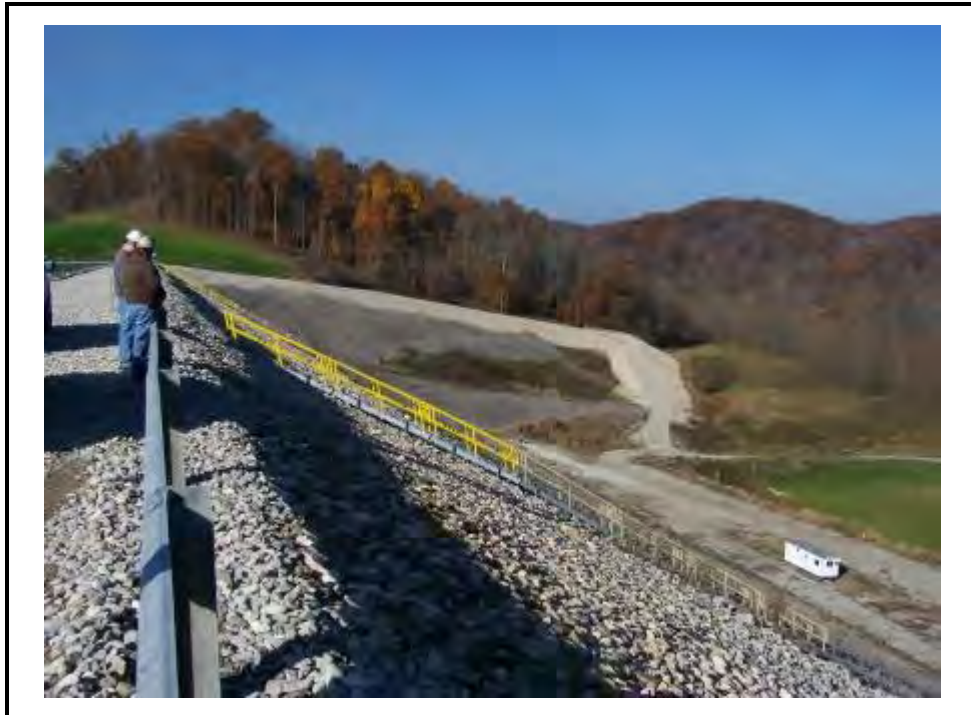
23

Downstream slope Horseford Creek Dam, looking west.

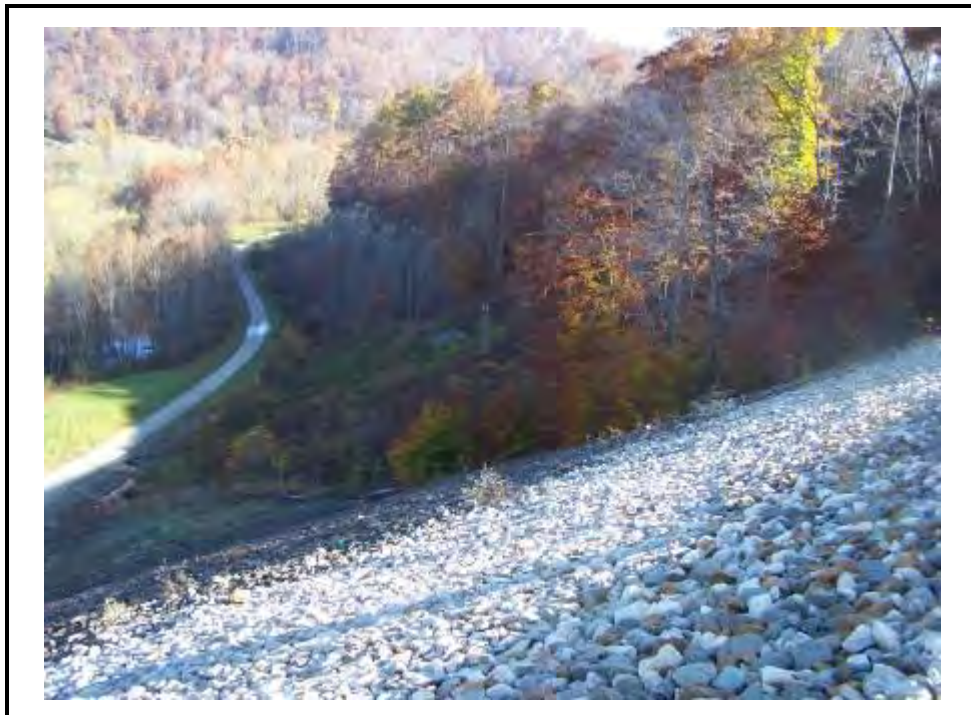
24

East abutment of Horseford Creek Dam, looking northeast.

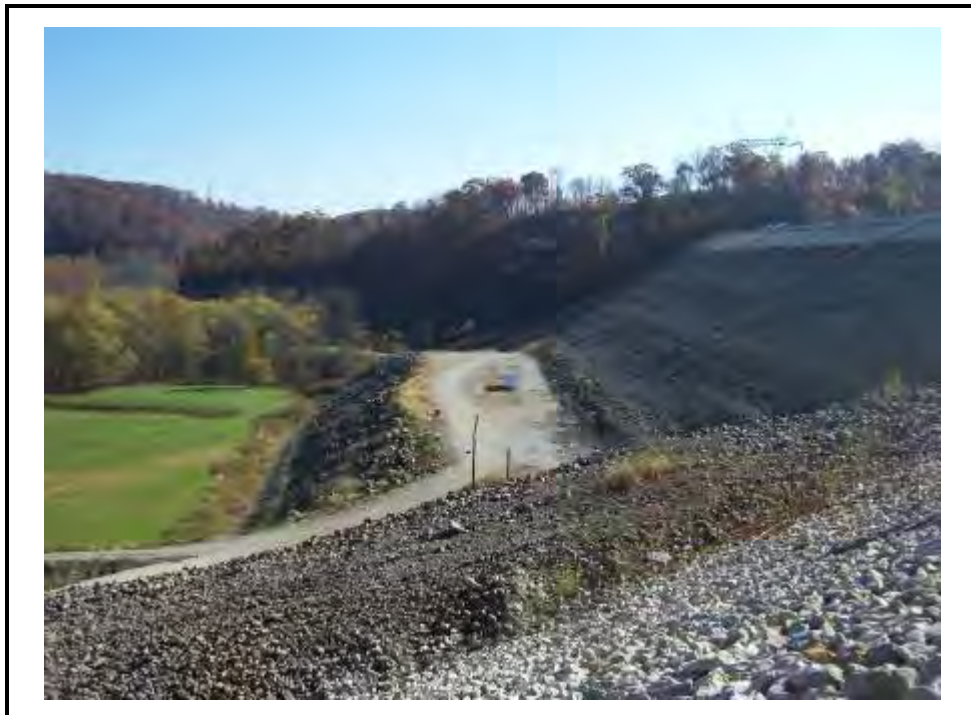
26

Downstream slope and buttress of Horseford Creek Dam, looking east.

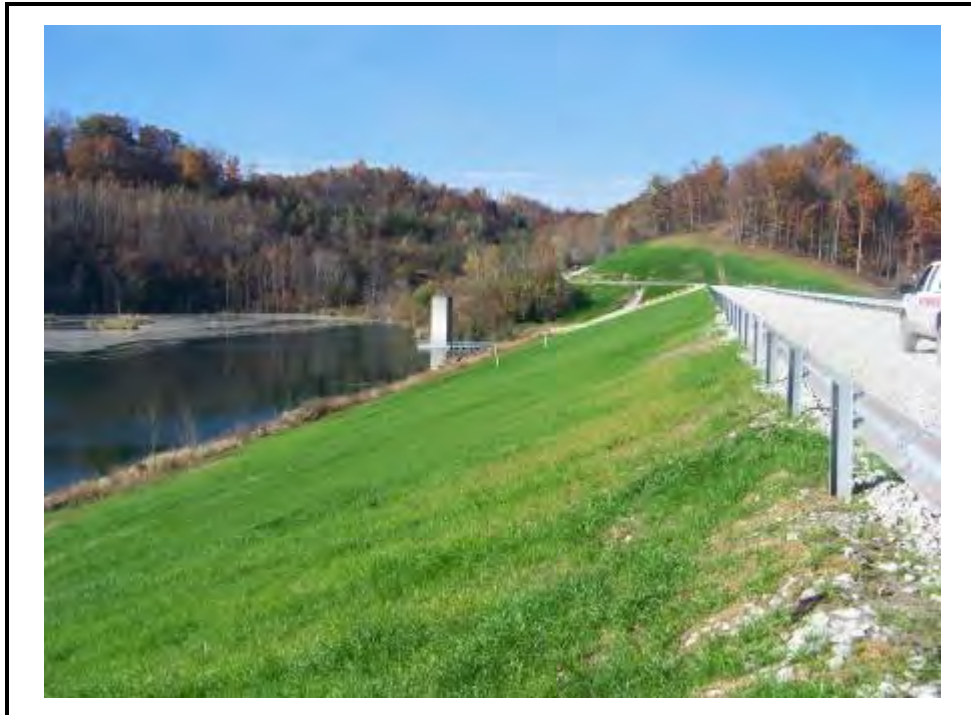
27

Upstream slope of Horseford Creek Dam, looking east.

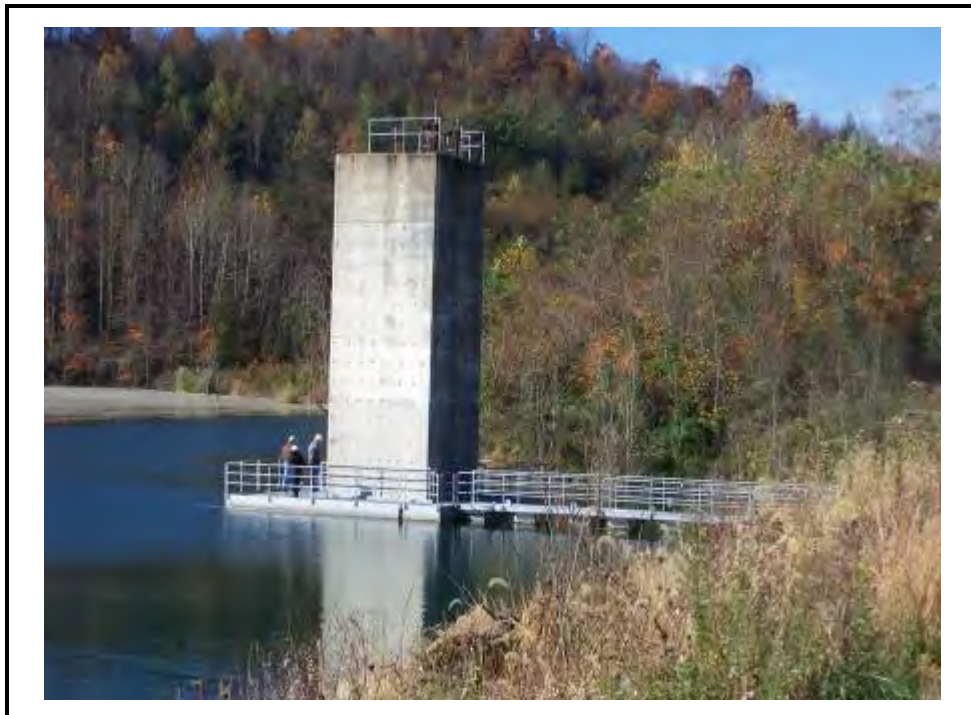
30

Outlet structure near west end of Horseford Creek Dam.

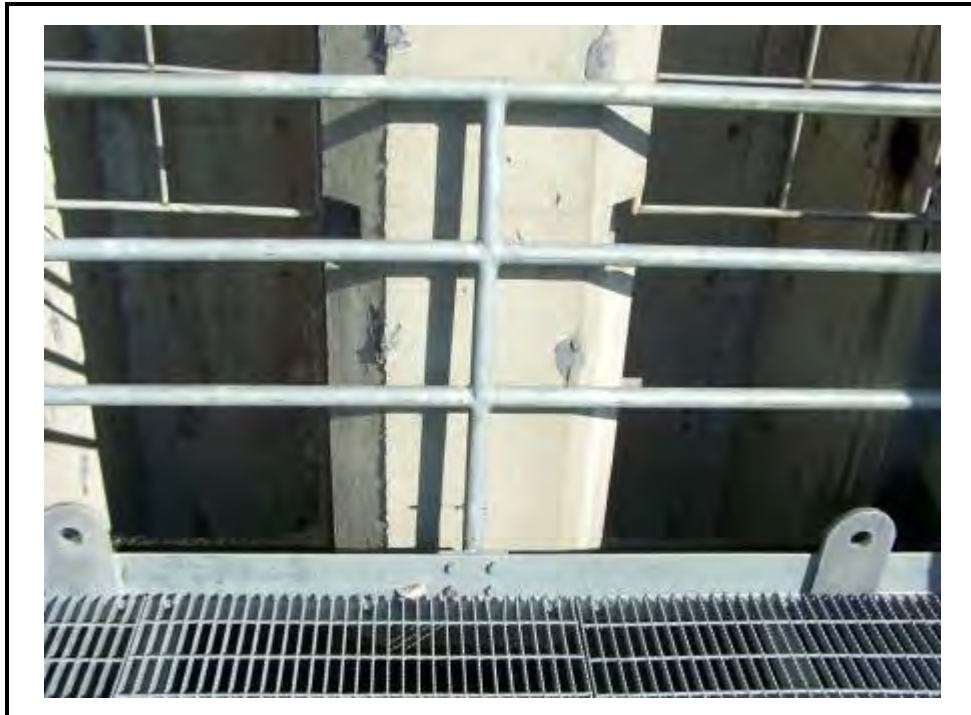
32

Twin stop log opening at Horseford Creek Dam outlet structure.

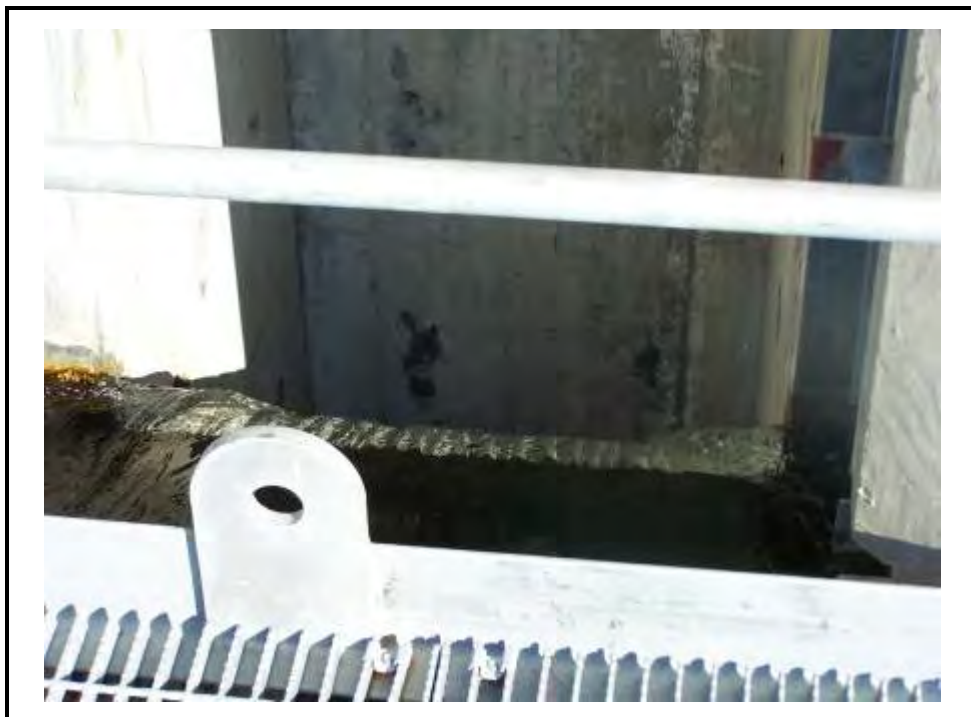
33

Close-up on one stop log opening at Horseford Creek Dam outlet structure.

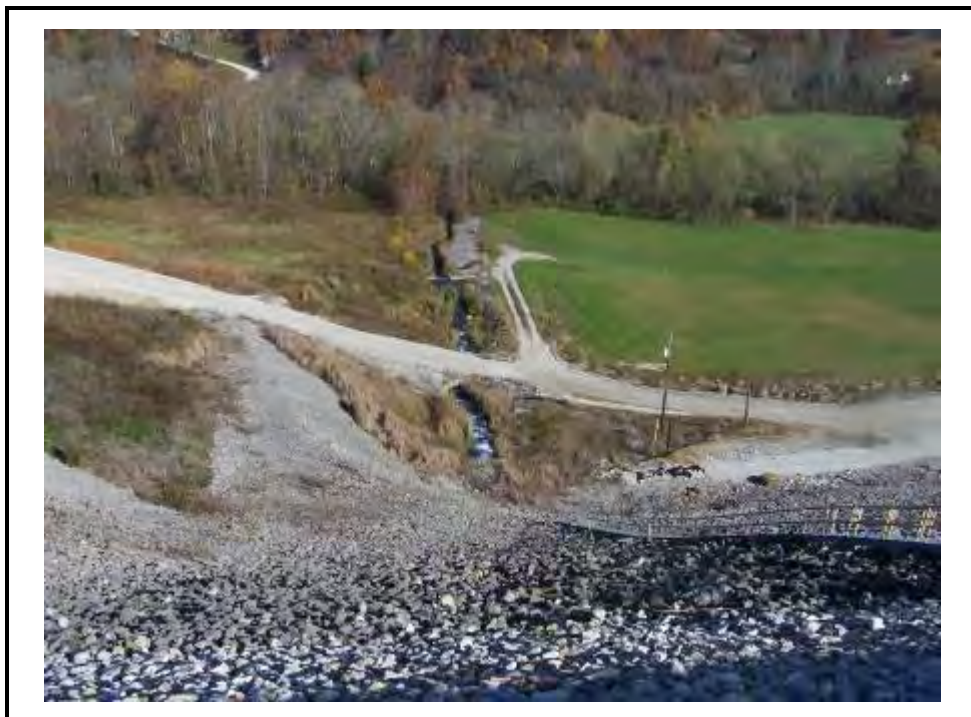
34

Discharge channel for Horseford Creek Dam.

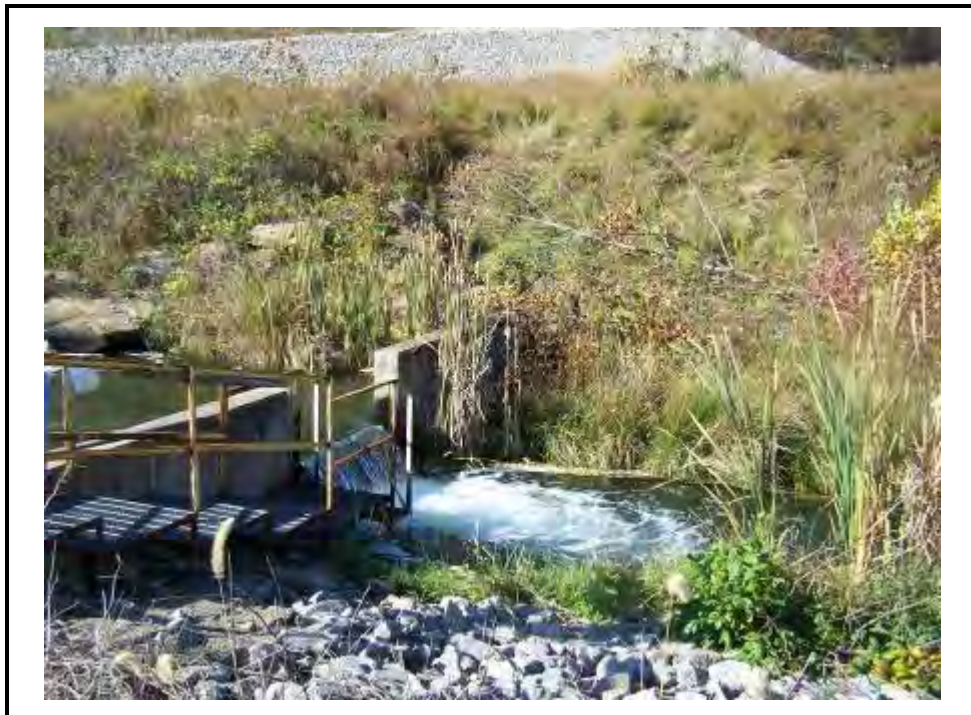
36

Stilling basin and NPDES outfall for Horseford Creek Dam outlet.

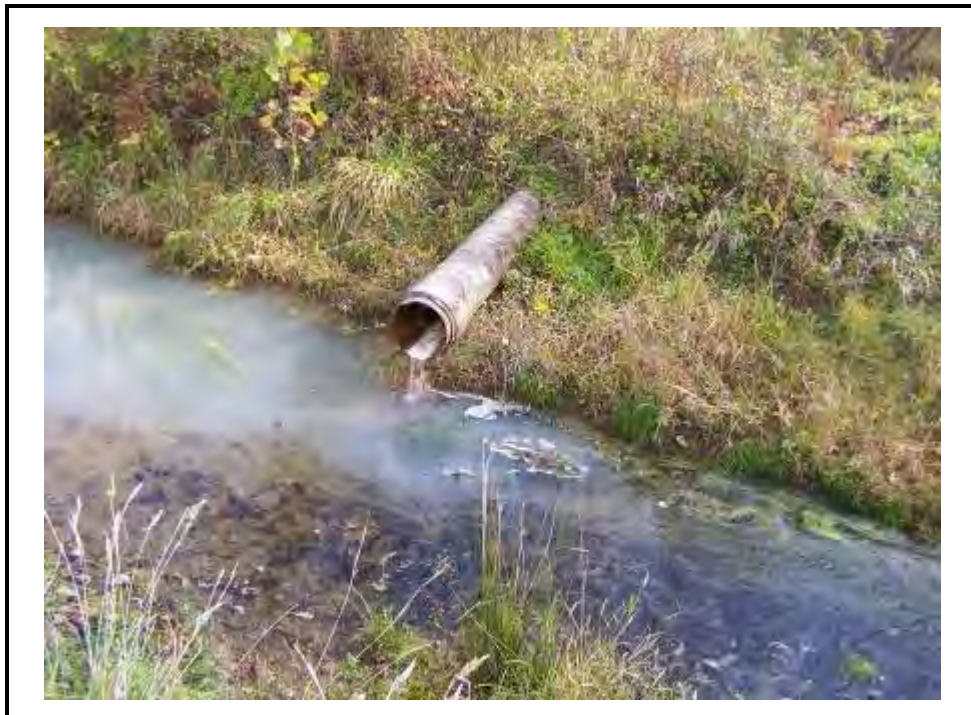
39

Drain pipe from east abutment area of Horseford Creek Dam.  
Note calcium deposits in water from limestone formations.

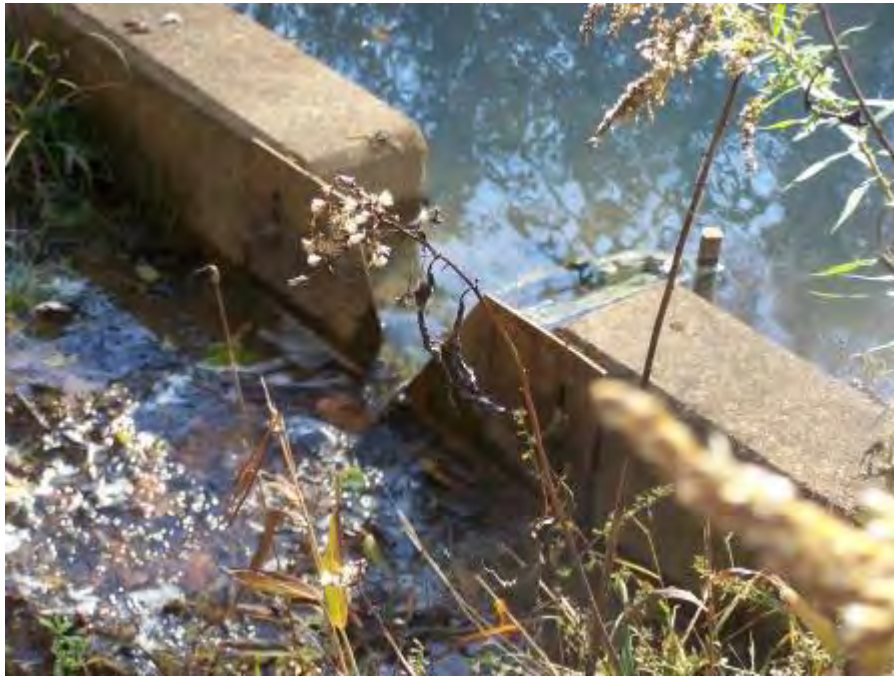
41

Monitoring weir at east abutment and toe drain discharge area.

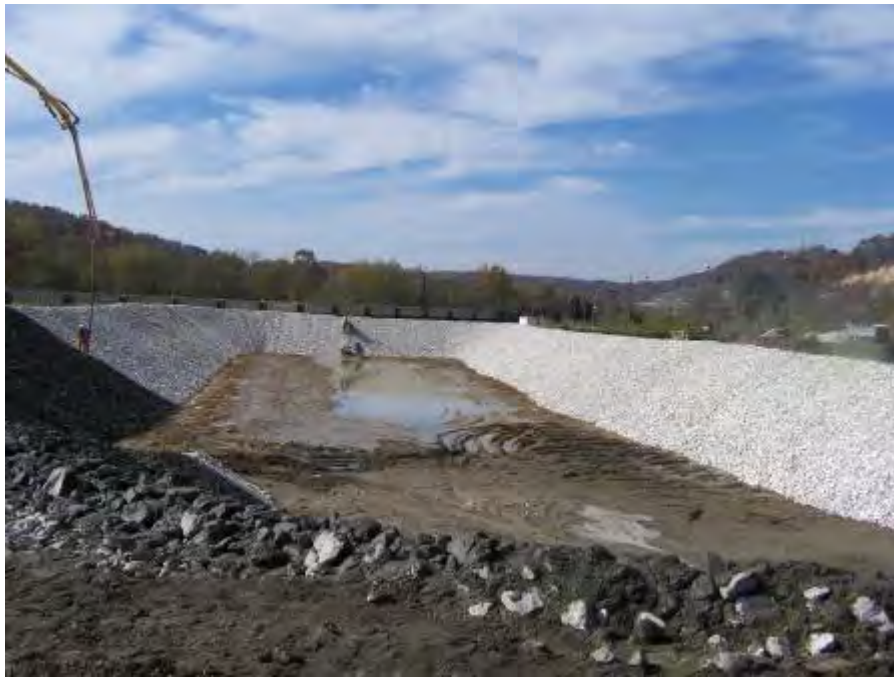
42

South Bottom Ash Pond looking west. AEP ws installing grouted rip rap on the inside slopes to reduce vegetation and erosion type maintenance.

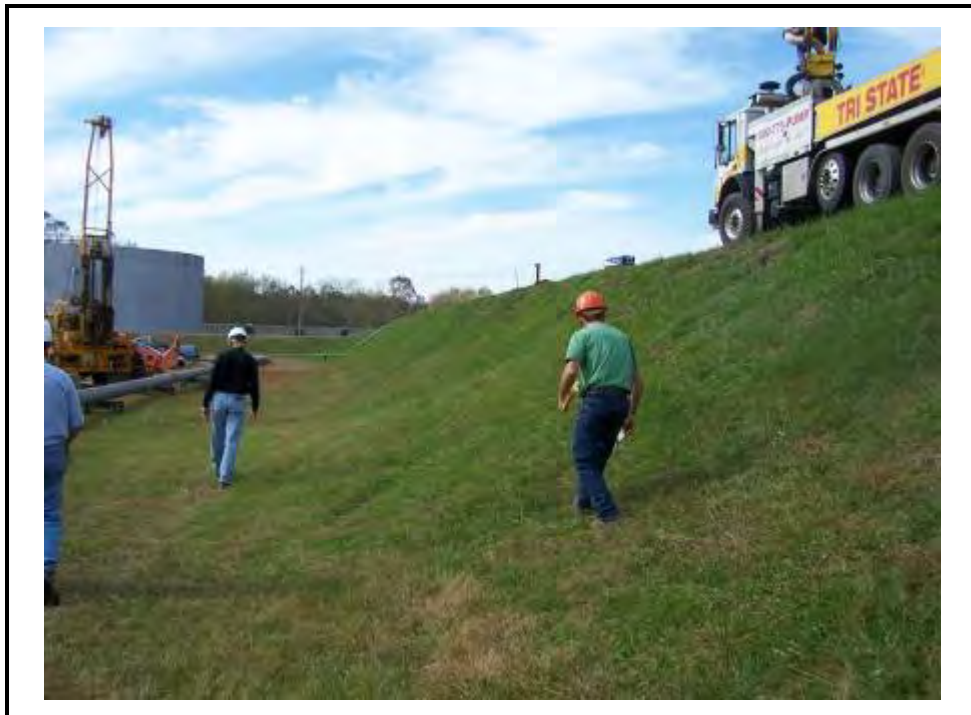
44

Downstream slope of South Dike at the Bottom Ash Complex along the south Bottom Ash Pond.

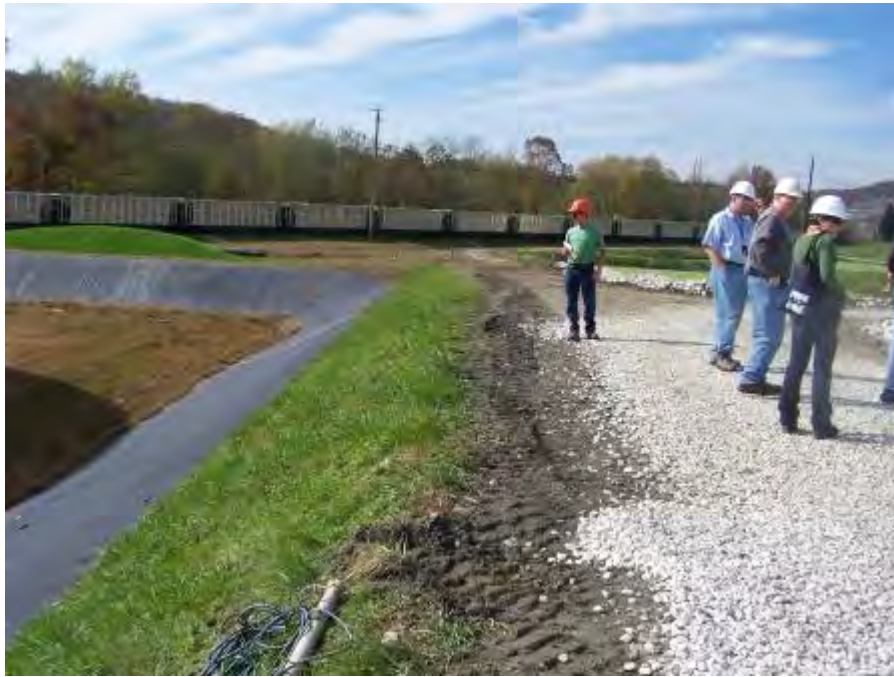
45

Crest of the South Dike at the Bottom Ash Complex looking west. Note dike crest slopes to about original grade adjacent to the south clear water pond.  
Liner on downstream slope is part of chemical spill containment berms.

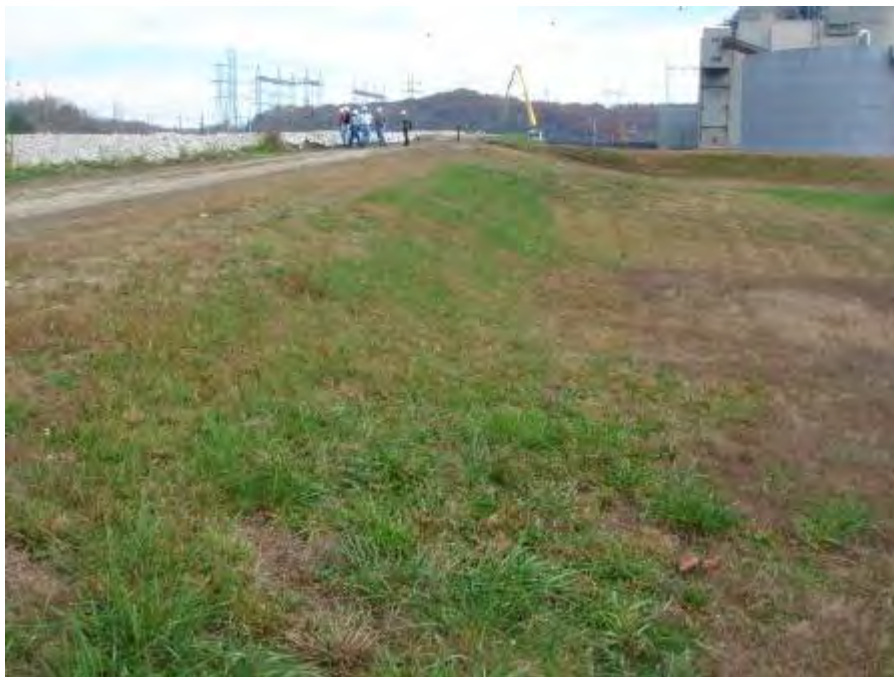
46

Downstream slope of South Dike at Bottom Ash Complex adjacent to south clear water pond, looking east.

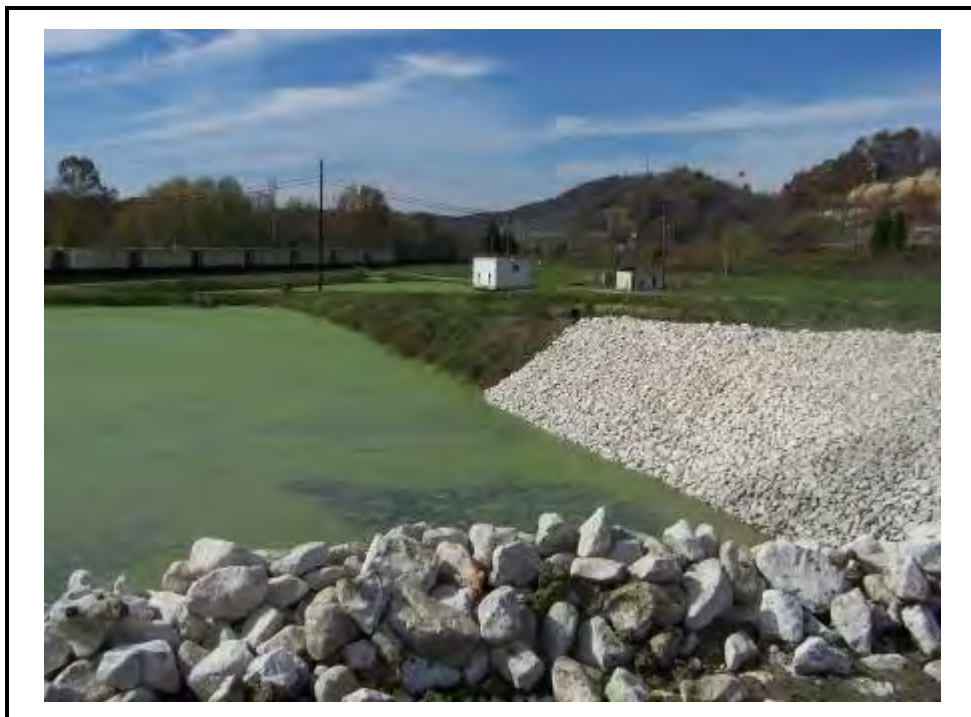
49

South side of Splitter Dike between south and north Clearwater Ponds.

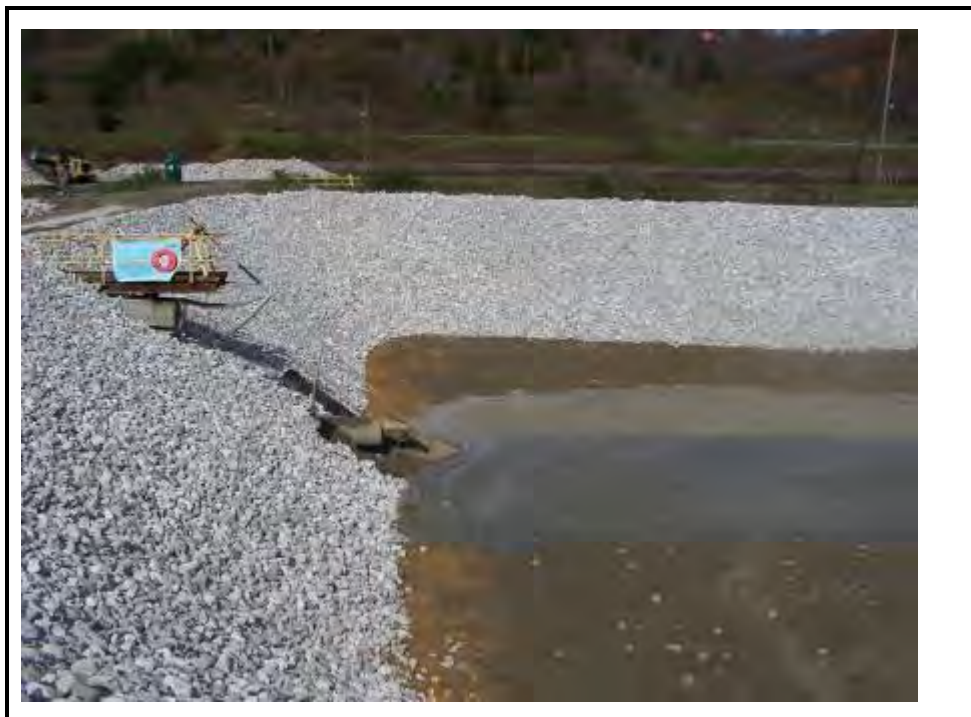
50

Decant structure (platform near top of slope) and pond drain (pipe near bottom of slope) from south Bottom Ash Pond into south Clearwater Pond.

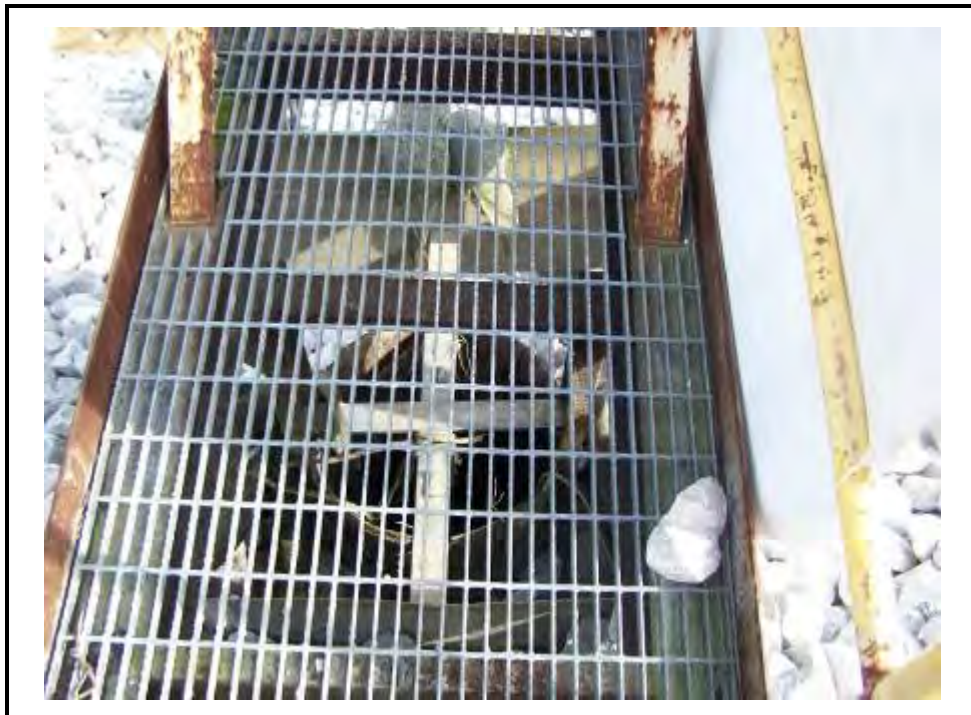
51

Close-up of south Bottom Ash Pond decant structure.

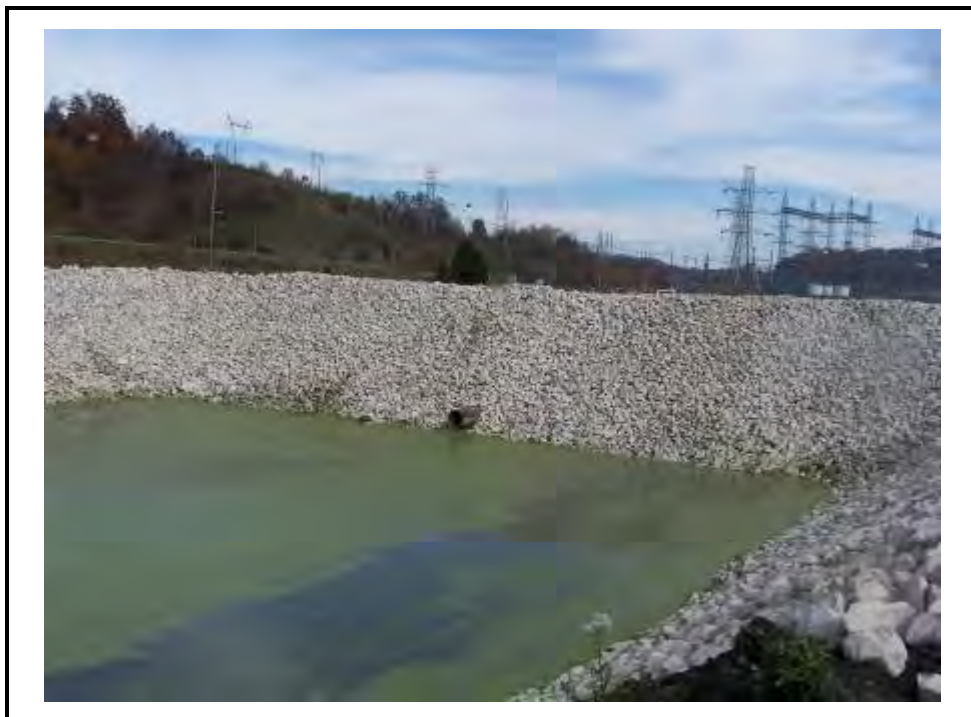
52

Discharge from south Bottom Ash Pond into South Clearwater Pond.
